Assembly and operating instructions
Elastic coupling

Nor-Mex[®] GHBS / GHBT

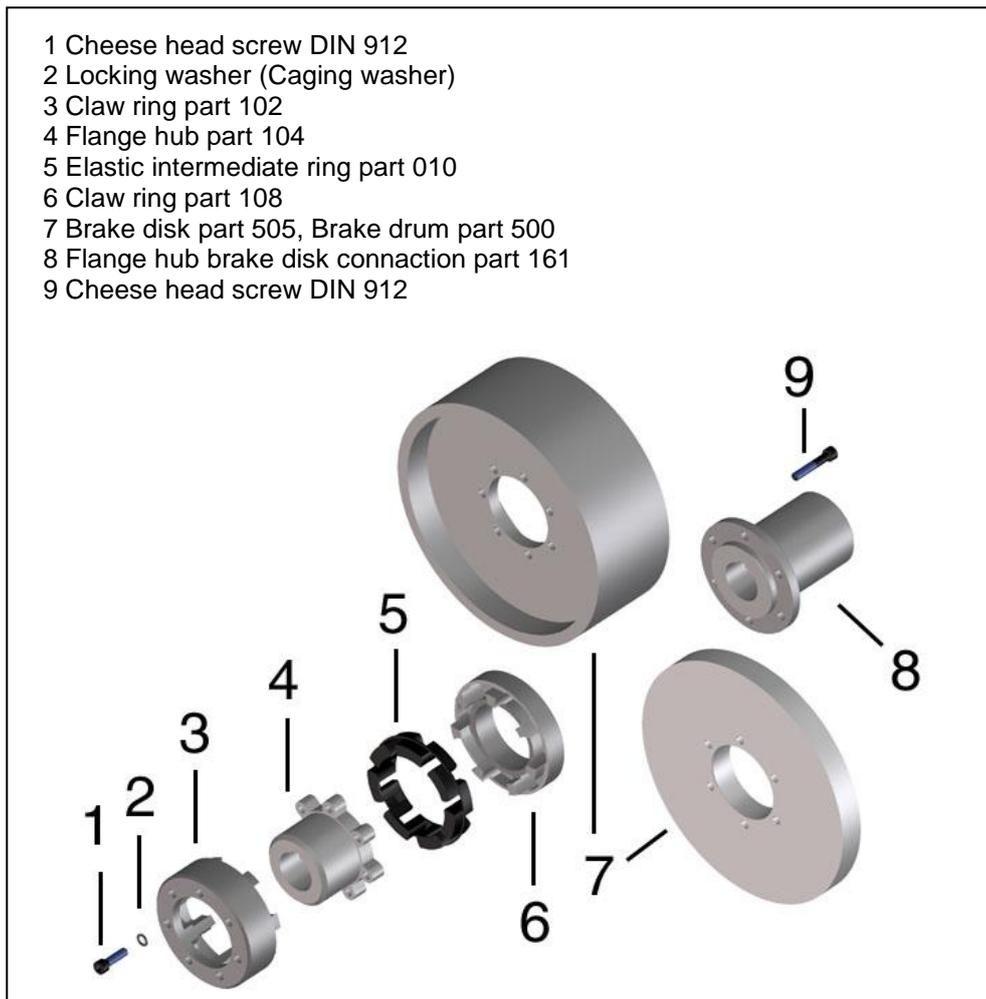
Fig. 1 Construction Nor-Mex[®] GHBS / GHBT

Claw ring (Pos. 3) and flange hub (Pos. 4), claw ring (Pos. 6) with brake disk / drum (Pos.7) and flange hub (Pos. 8), are bolted to each other when supplied.
 Balanced parts are position marked to each other.

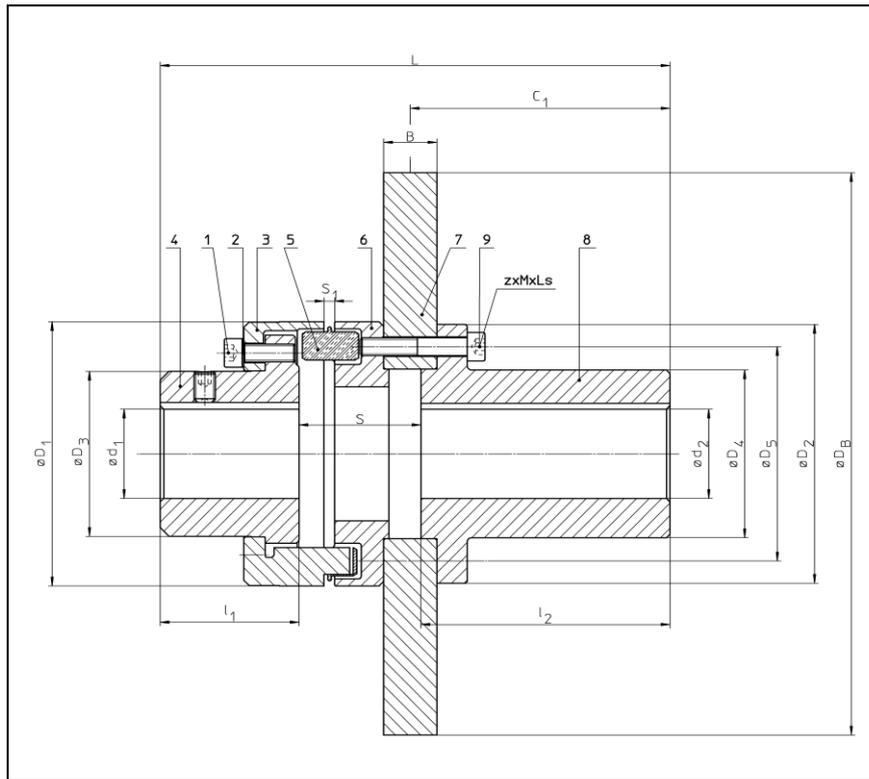
Fig. 2 Nor-Mex[®] GHBS

Nor-Mex GHBS D ₁ -D _B x B	T _{Cnom} Pb72 [Nm]	T _{Cpeak} Pb72 [Nm]	T _{BS} ¹⁾ [Nm]	n _{max} [min ⁻¹]	d ₁ max [mm]	d ₂ max [mm]	C ₁ [mm]	D ₂ [mm]	D ₃ [mm]	D ₄ [mm]	D ₅ [mm]	L [mm]	l ₁ [mm]	l ₂ [mm]	S [mm]	S ₁ [mm]	z x M x Ls	m [kg]
148-315x30	390	800	1000	4500	65	65	146	145	92,5	94	171	286,5	78	140	68,5	6+1	6 x M10 x 55	34
168-355x30	630	1300	1600	4000	75	80	146	168	104,5	115	145	304,5	87	140	77,5	6+1,5	8 x M10 x 60	46
168-400x30				3750														42,3
168-450x30	1050	2000	2750	3500	85	95	146	194	121,5	135	170	321,5	97	140	84,5	6+1,5	8 x M12 x 65	61
194-400x30				3000														89,4
194-560x30	2400	4800	4200	2750	100	115	146	225	146,0	165	200	354,0	117	140	97,0	6,5+2	10 x M12 x 70	92
240-450x30																		112,5
240-560x30	3700	7500	8700	2500	115	135	146	265	164,0	195	230	381,5	137	140	104,5	7+2	10 x M16 x 75	128
240-630x30																		121
265-500x30	4900	10000	9800	2400	130	153	146	265	181,0	215	260	396,5	147	140	109,5	8+2	10 x M16 x 75	132,8

265-560x30				168														
265-710x30	4900	10000	9800	2250	130	153	146	265	181,0	215	260	396,5	147	140	109,5	8+2	10 x M16 x 75	169
295-630x30				171														
295-710x30																		171

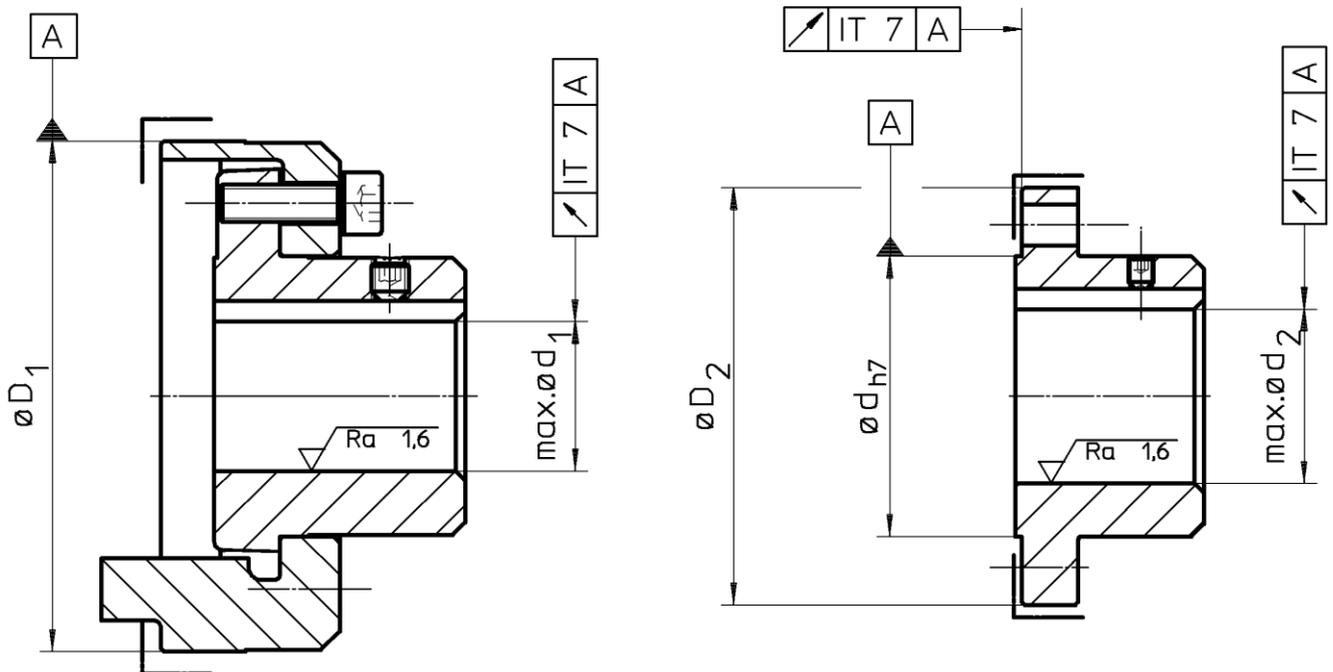
Fig. 3

- Remove the elastic intermediate ring (Fig 3, Pos. 1).
- Clean the borehole of the flange hubs and the shaft ends before installing. The surfaces must be clean, dry and grease-free
- Use suitable installation aids and hoists such as cranes or pulley blocks in the case of bigger couplings.
- Pull the flange hubs on to the shaft end in its intended position (Fig 3, Pos.2).

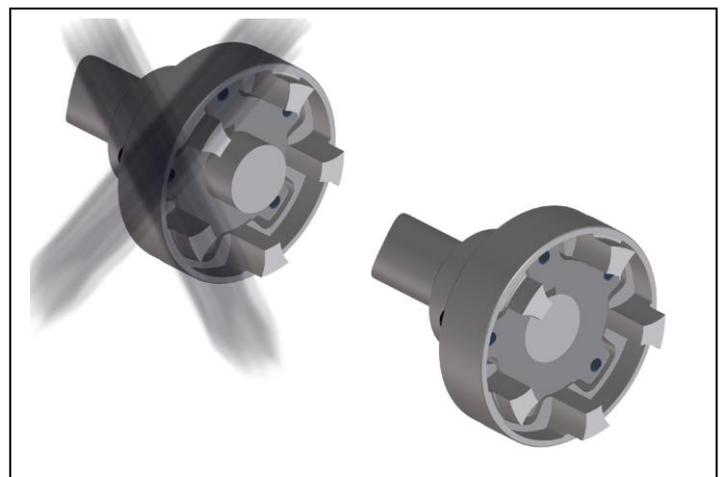
Fig. 4

- Mount the hub so that the shaft ends are flush with the interior borehole opening (Fig 4). Protruding shaft ends prevent radial mounting and dismounting of the brake disk. Pay attention to possible differing agreements!
- Secure possible available setscrews by tightening with an adhesive e.g. Loctite 222 against automatic loosening and flying out.

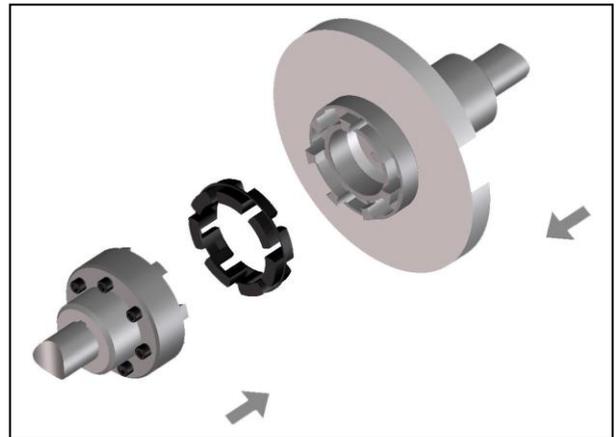
Fig 5

- For easier mounting the elastic intermediate ring can be provided with a slip additive (e.g. Talcum) before introduction.
- Fit the intermediate ring into one half of the coupling.
- Push the shaft ends with the mounted coupling halves together (Fig 5).
- Adjust the coupling according to the following specifications in “8 Coupling adjustment”.

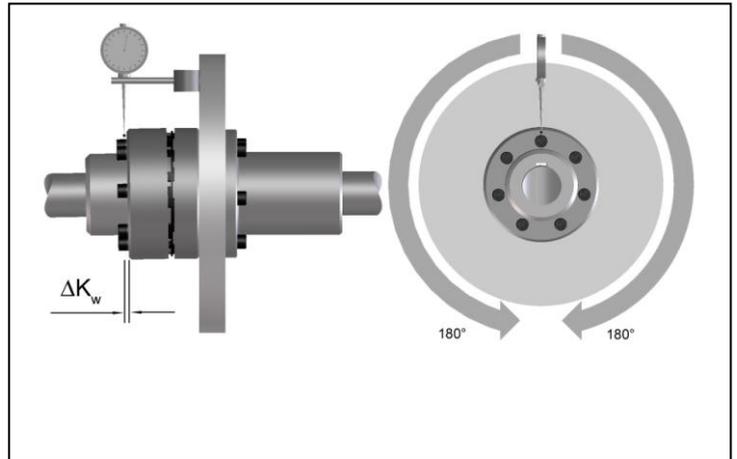
Fig. 6

- Measure on the face of the external diameter a complete rotation (360°). Determine in this case the greatest deviation ΔK_{w1} as well as the smallest deviation ΔK_{w2} (Fig. 6).
- Calculate the angular misalignment $\Delta K_w = \Delta K_{w1} - \Delta K_{w2}$.
- The values in table 2 are valid for a reference rotation speed of 1500 min^{-1} .

Size	148	168	194	240	265	295
ΔK_{wmax} [mm]	0,3	0,3	0,3	0,3	0,3	0,3

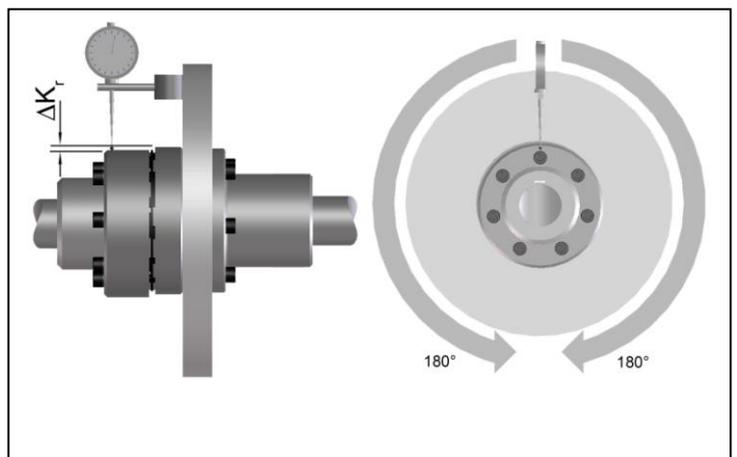
Fig. 7

- Measure a complete rotation (360°). Determine in this case the greatest deviation ΔK_{r1} as well as the smallest deviation ΔK_{r2} (Figure 7).
- Calculate the radial displacement $\Delta K_r = 0,5 \times (\Delta K_{r1} - \Delta K_{r2})$. Pay attention to the operational sign of the measured values.
- The values of table 3 are valid for a reference rotation speed of 1500 min^{-1} .

Size	148	168	194	240	265	295
ΔK_{rmax} [mm]	0,3	0,3	0,3	0,3	0,3	0,3

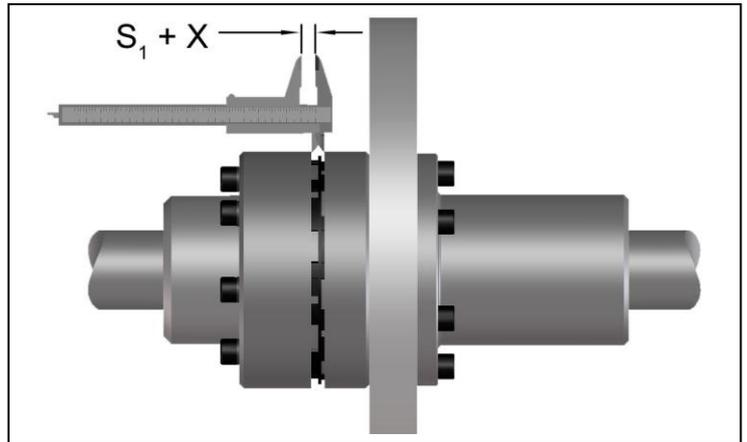
Fig. 8

- Measure the axial S_1 gap measurement according to figure 8.
- Keep, when aligning the gap measurement S_1 , to the maximum permissible tolerance X according to table 4.

If the installation dimension remains over S_1 , the claw ring and brake disk can not be lifted out!
 If greater axial displacements are expected in operation, consultation with TSCHAN GmbH is necessary.

Size	148	168	194	240	265	295
S_1 [mm]	6	6	6	6,5	7	8
X [mm]	+1,0	+1,5	+1,5	+2,0	+2,0	+2,0

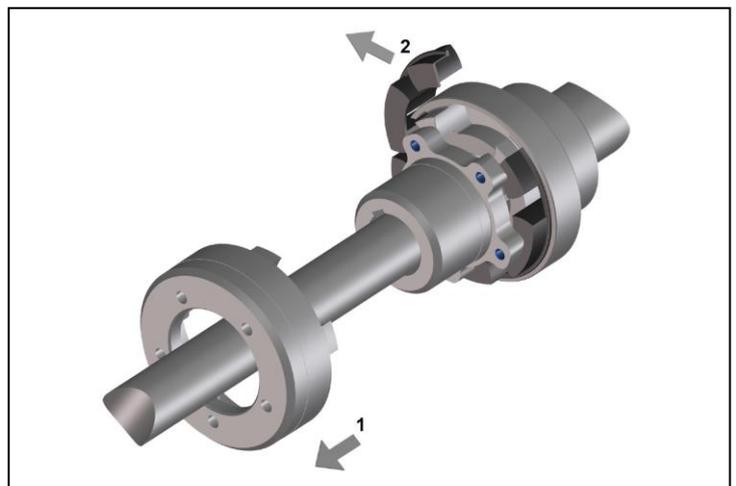
Fig. 9

- Remove the fixing screws on the claw ring and push it back (Fig. 9, Pos. 1).
- Secure the claw ring against unintentional displacement.
- Cut through the intermediate ring at a connecting part (Fig. 9, pos. 2).
- Pull out the intermediate ring. Start at the cut through connecting part.

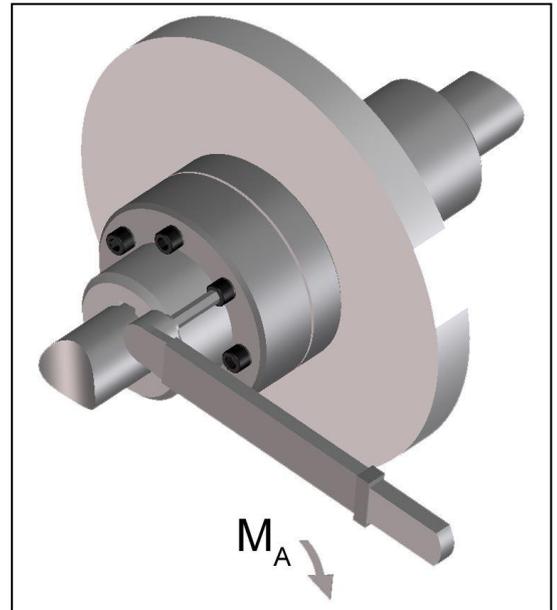
Fig. 10

- Mount the claw ring into its marked position. When doing this pay attention also that the parts not tilt when being joined to the centering seat.
- Slightly tighten the screws uniformly.
- Tighten the claw ring threaded joint with the tightening torque M_A stipulated in table 6 (Fig. 10).
- Check the alignment of the coupling according to the specifications in „8 Coupling adjustment”

Size	148	168	194	240	265	295
DIN 912- 8.8	M10	M10	M10			
DIN 912-10.9				M12	M14	M14
M_A [Nm]	49	49	49	125	200	200

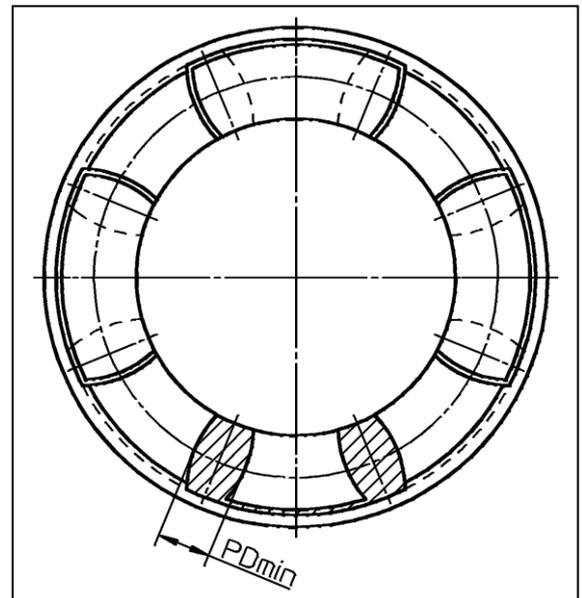
Replace the elastic buffer ring as soon as the coupling has a distinct torsional backlash, or if the minimum buffer thickness (PD_{min} , Fig. 11) acc. to table 7 has been reached.

Fig. 11 Buffer thickness

Size	148	168	194	214	240	265	295
PD_{min} [mm]	10	10	10	10	11	12	13

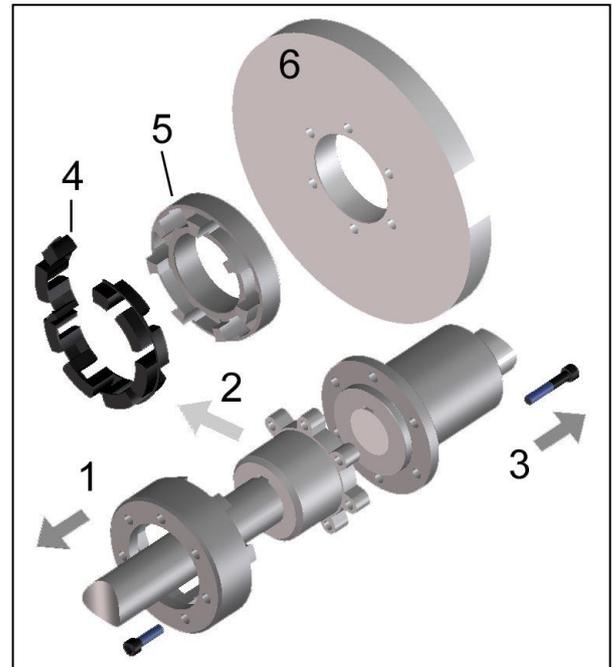
Fig. 12

- Remove the holding-down screws on the claw ring and push it back (Fig. 12, Pos. 1)
- Cut through the intermediate ring at a connecting joint (Fig. 12, Pos. 4).

- Pull out the intermediate ring. Begin at the cut through connecting joint.
- For replacing the brake disk, remove the cheese head screws (Fig. 12, Pos. 5) on the brake disk side. It is now possible to radially take out the claw ring (Fig. 12, Pos. 5) and to replace the brake disk (Fig. 12, Pos. 6). If the brake drum needs to be replaced, one of the coupling halves has to be moved axially.

- Install the claw ring again and tighten the brake disk-side cheese head screws to the torque M_{A-BS} specified in Table 9.
- Cut through the new intermediate ring at a connecting joint and position it between coupling flange and flange hub.

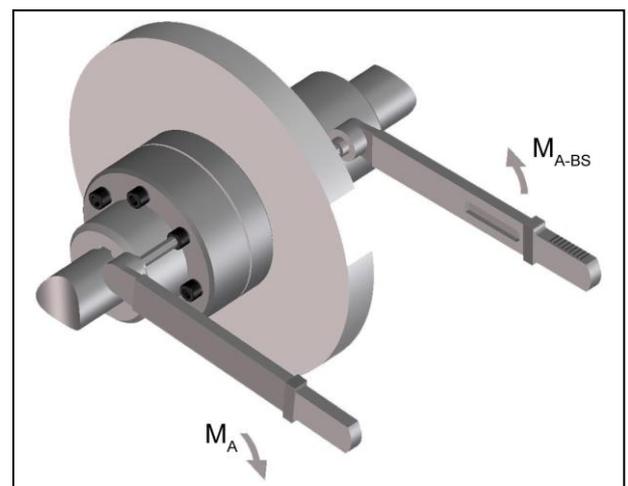
Fig. 13

- Mount the claw ring into its marked position.
- Tighten the screws slightly.
- Tighten up the claw ring threaded joints with the tightening torque M_A stipulated in table 8 (Fig. 13).
- Check the alignment of the coupling according to “8 Coupling adjustment“.

Size	148	168	194	240	265	295
DIN 912- 8.8	M10	M10	M10			
DIN 912-10.9				M12	M14	M14
M_A [Nm]	49	49	49	125	200	200

Size	148	168	194	240	265	295
DIN 912- 8.8	M10	M10	M12	M12	M16	M16
M_{A-BS} [Nm]	49	49	85	85	210	210
